Frost Protection for Roads and Railways

Røros test site: 1 year of data

NADim-seminar

November 30, 2017

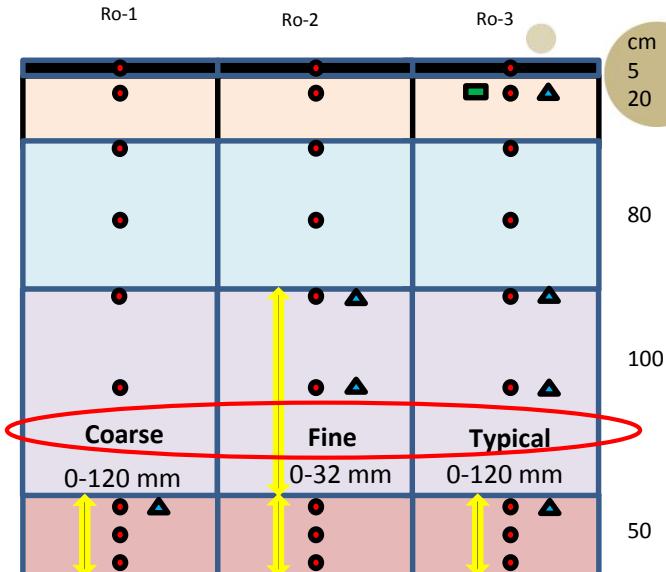
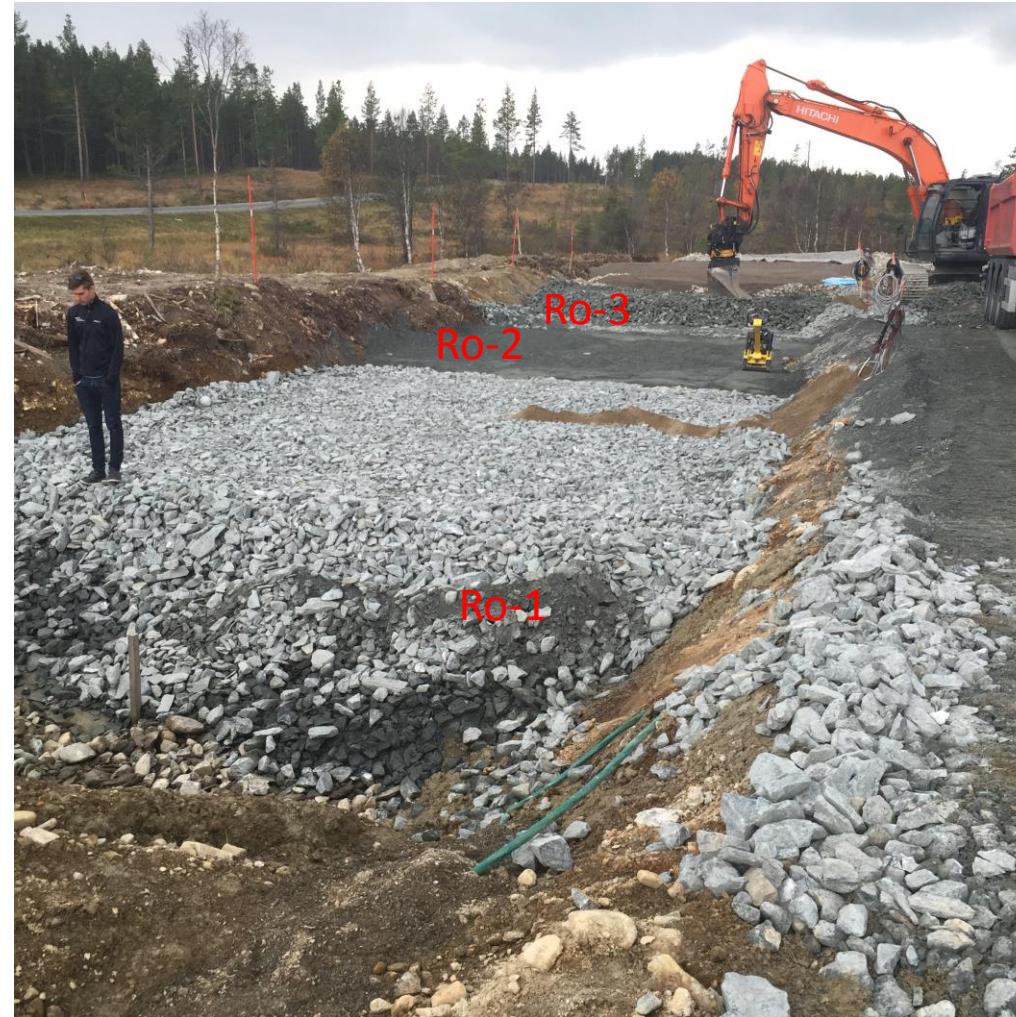
Variation of grading curves: Road Sections Ro-1 – Ro-3

- 3 different grading in frost protection layers

- Ro-1: 0-120 mm, 'Coarse'
- Ro-2: 0-32 mm, 'Fine'
- Ro-3: 0-120 mm, 'Typical'

Ro-1: 0-120 mm, 'Coarse'
Ro-2: 0-32 mm, 'Fine'
Ro-3: 0-120 'Typical'

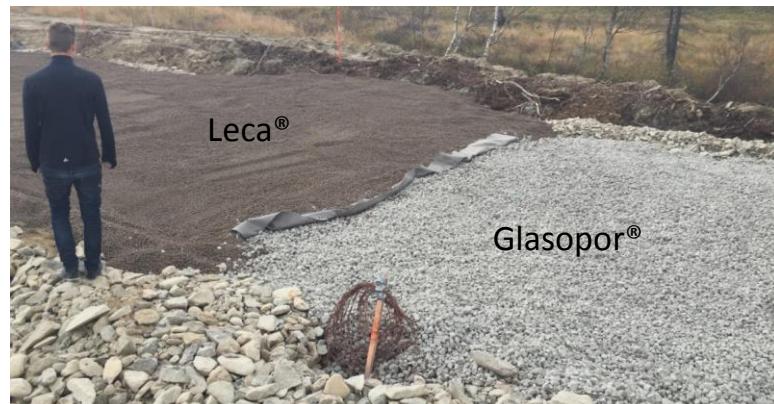
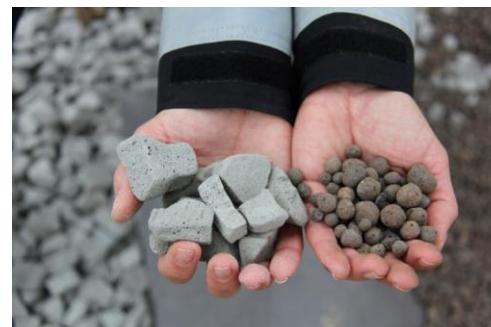
Variation of insulation material: Road Section Ro4 –Ro6

- 2 products: Expanded clay pebbles and Foam Glass
 - Expanded clay from Leca®
 - 0-32 mm in Ro-4
 - 10-20 mm in Ro-5
 - Foam Glass from Glasopor®
 - 10-60 mm in Ro-6

cm
5
20
20
60
70
80
